SERVICE BULLETIN

RMD / RML 8555
BEEPING

REFRIGERATOR BULLETIN R84-A

RMD/RML 8555 beeping

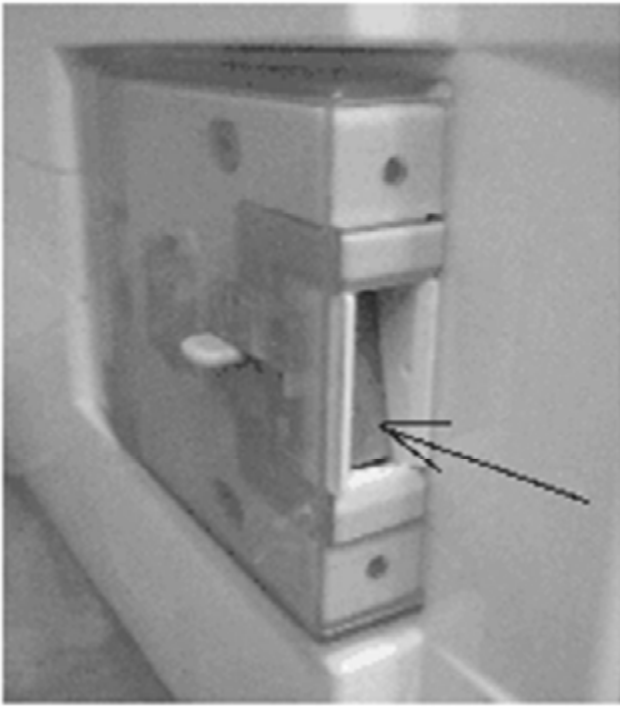
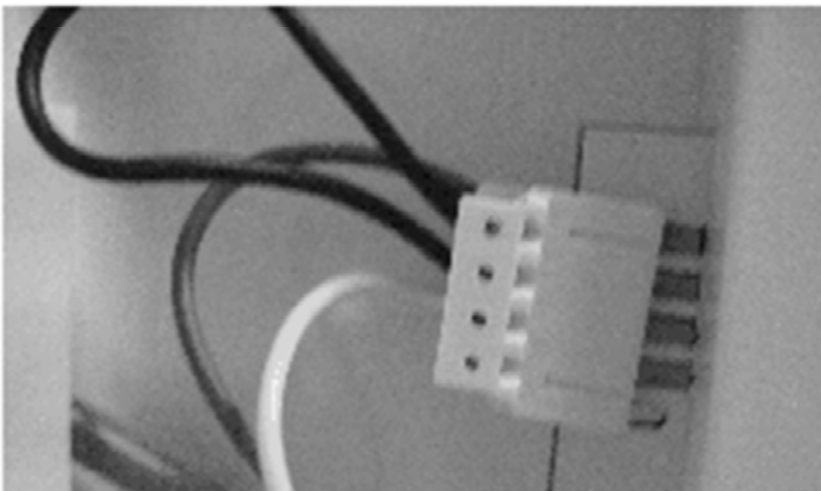
Figure 1

Complaint: Unit is beeping

Fix: The beeping indicates a failure, meaning the door is open. This can occur from a number of issues.

Indicator	Fault	Remedy
② flashing + ⑧ acoustic signal 20 s	230V mode: "230V" not available or voltage too low	Check mains power connection, mains voltage, fuse
④ flashing + ⑧ acoustic signal 20 s	12V mode: "12 V" not available or voltage too low	Check 12 V connection, on-board battery, fuse AES: Check D+ signal
③ flashing + ⑧ acoustic signal 20 s	GAS/Automatic mode: Flame not ignited	Check gas supply (gas bottle, gas valve) Press the button after clearing the fault.
Acoustic signal, 15 s, at 2 minute intervals	Interior lighting is switched on	Close door, check door contact
② flashing +	230V mode: 230V heating element	Arrange replacement of 230V heating element,

1. The lighting/lock device needs to be moved to the edge of the refrigerator so that it makes contact. (Fig 1)
2. Condensation that may form and settle on the printed circuit board may cause an audible error condition that continuously beeps indicating the door is open, whether it is open or not. (Fig 2)
3. The lighting/ lock device needs to be changed.

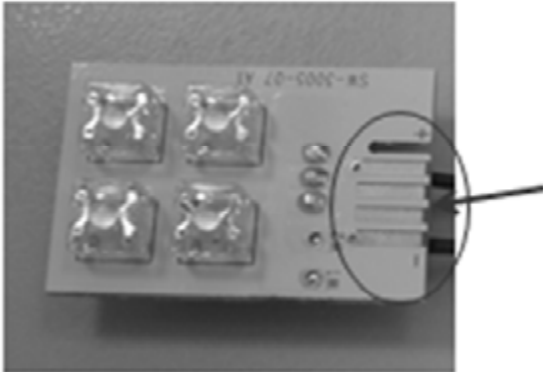
Figure 2

Dometic Interior Light RM8XXX

Problem: Due to the narrow contact locations, a buildup of condensation may result in an erroneous enunciation of the audible “door open” alarm. Any condensation build up may be sufficient to bridge the space between the contacts and cause the “door open” alarm to activate.

1. Remove cover

2. Remove connector

3. Dry contacts with cloth

4. Re-assemble light box
