This program will address the most common system problems associated with the A&E Patio Awnings supplied by The Dometic Corporation. Our intent is to provide you with a guideline of checks to make, should you encounter one of the following symptoms.

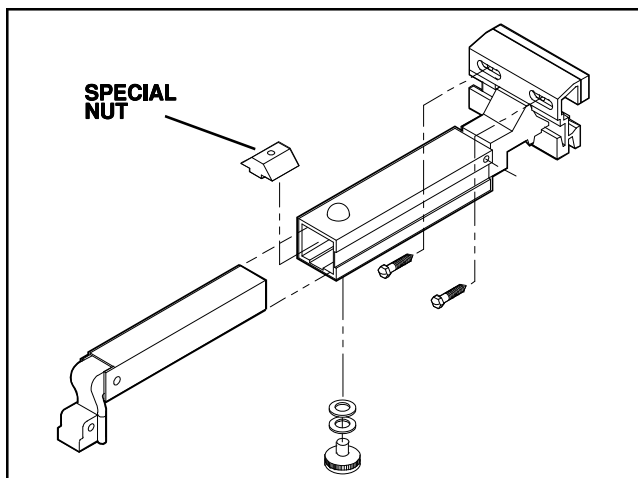
On some arm assemblies the nutsert has been replaced with a **SPECIAL NUT**. If the knob will not tighten, first separate the rafter assembly. Turn the knob to determine if the special nut is stripped. If so, replace the special nut. If you cannot turn the knob, it will be necessary to replace both the special nut and the back adjustment knob.

NOTE: The special nut could be a large hex nut as well as the one shown.

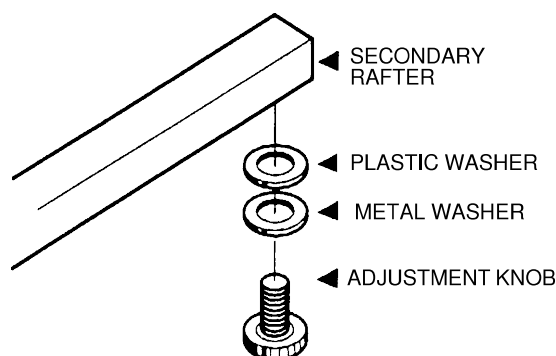
1.2 WASHER STACK-UP

Washer stack-up merely means the proper positioning of the washers on the stud of the black adjustment knob. Remove the knob and check for proper washer position. The plastic washer should be against the main rafter, and backed by the metal washer for stiffness. If the stack-up is not proper it should be corrected.

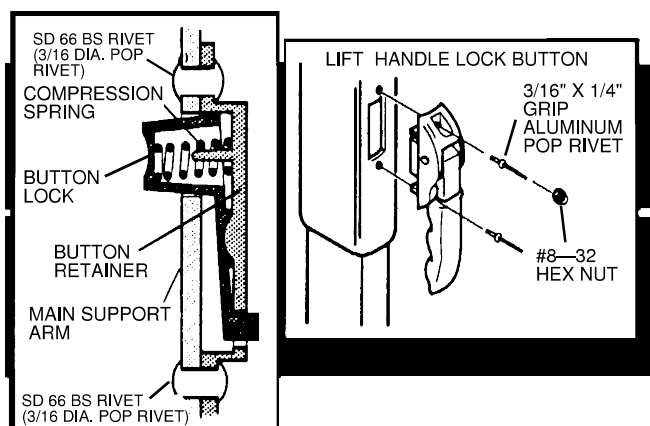
1.3 PUSH BUTTON ASSEMBLY

The push button assembly locks the main support arm to the adjustable arm assembly and controls the height of the awning in the open position. To check it, open the awning to full extension. Look inside the main support arm, and activate the push button to see if the locking pin is moving in and out of the hole in the adjustable arm assembly. If the locking pin does not move, or has been

broken off, the push button assembly must be replaced. At times the lock pin of the push button assembly can break off and jam between the push button housing and the adjustable arm assembly, making it difficult to extend the main support arm.

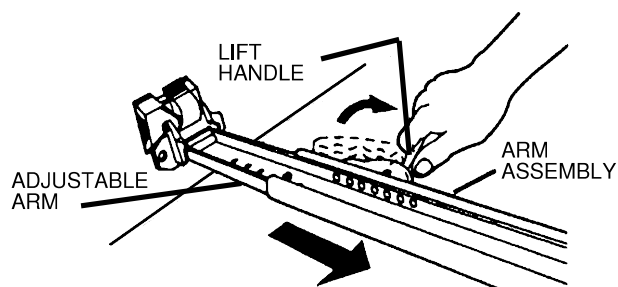
1.4 ADJUSTABLE ARM ASSEMBLY

The adjustable arm assembly allows for telescoping height adjustment of the main support arm, and it connects to the bottom mounting bracket to support the weight of the awning. If the main support arm cannot be extended freely, the adjustable arm assembly should be checked. Remove the adjustable arm assembly and check for nicks, burrs, bends or twists. If any deflection is noted, the adjustable arm assembly must be replaced. For ease of operation apply GO-EASY, a special lubricant.

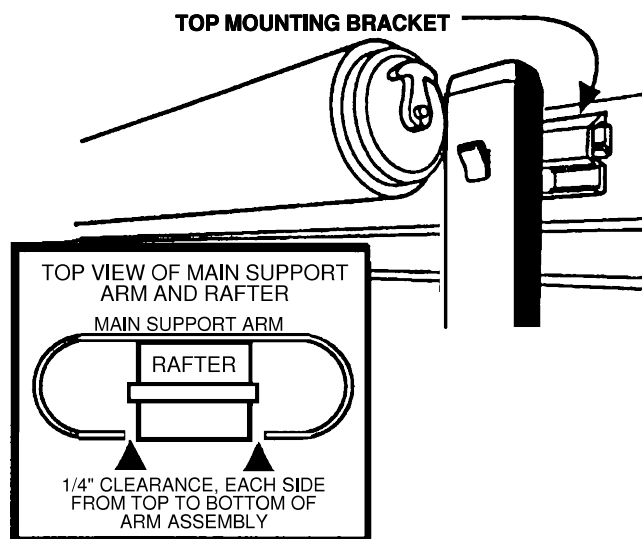
1.5 TOP MOUNTING BRACKETS

The top mounting bracket supports the main rafter assembly to hold the awning in the open extended position, and allows the rafter to pivot into the "C" channel of the main support arm. Each top mounting bracket should be mounted directly over the awning rail so the screws go through the "C" portion of the rail.

On the Series 9000 awning the top mounting bracket can be mounted lower when possible. If the top mounting bracket is mounted above center of the awning rail, the aluminum guard may not cover the fabric completely in the closed position. If this is the case, relocate the top mounting bracket accordingly.

The top mounting brackets have slotted holes for the mounting screws, allowing them to be adjusted side to side. To adjust the brackets, close the awning and sight down the main support arm and the main rafter. The clearance on each side of the rafter should be approximately 1/4 inch. If clearance is not appropriate, adjust the top mounting bracket(s) as necessary.

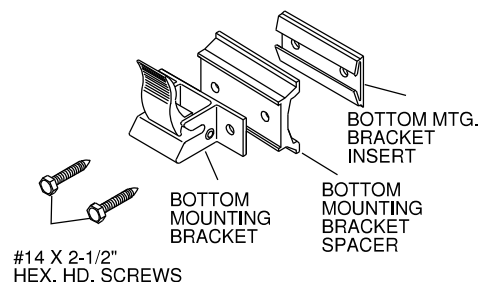
1.6 BOTTOM MOUNTING BRACKETS

The bottom mounting brackets are screwed to the floor line of the unit, and they support the weight of the awning. They also provide a quick release to set up the awning in the patio position.

If a bottom mounting bracket settles, sags, or becomes loose it can reduce the clearance between the top casting of the torsion and the extension of the top mounting bracket, making operation difficult.

Check the bottom mounting bracket for looseness or settling, and tighten or reposition it accordingly for proper operation.

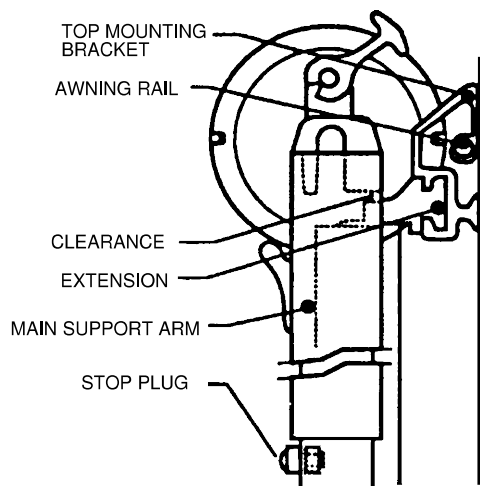
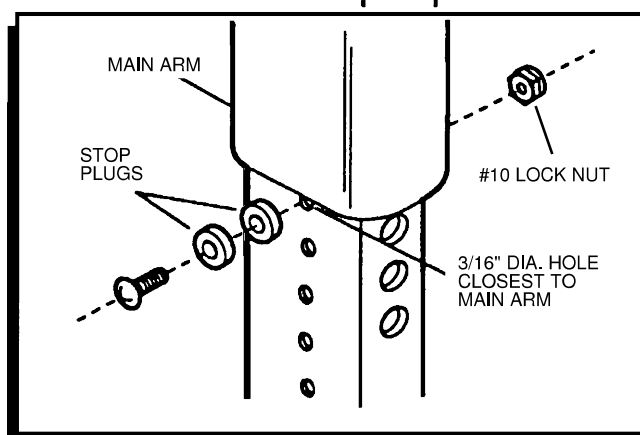
1.7 STOP PLUG

The stop plug is a mechanical stop that supports the main arm when opening and closing the awning. It controls the clearance between the top casting of the torsion to the extension of the top mounting bracket. This clearance should be 1/4 inch to 1 inch. To adjust the clearance, raise or lower the stop plug as needed. On the 9000 and 9500 Series awning the clearance should be kept to a minimum for best operation.

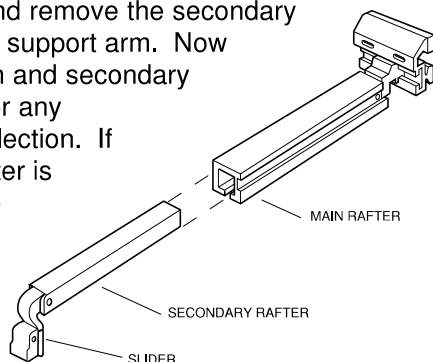
1.8 RAFTERS

The rafters telescope from the top mounting brackets to the main support arms to provide tension on the fabric in the full open position. If the rafters are bent or twisted, this will hinder the operation of the awning. Open the awning and remove the secondary rafter from the main support arm. Now sight down the main and secondary rafters and check for any bends, twists or deflection. If one or the other rafter is not true it should be replaced.

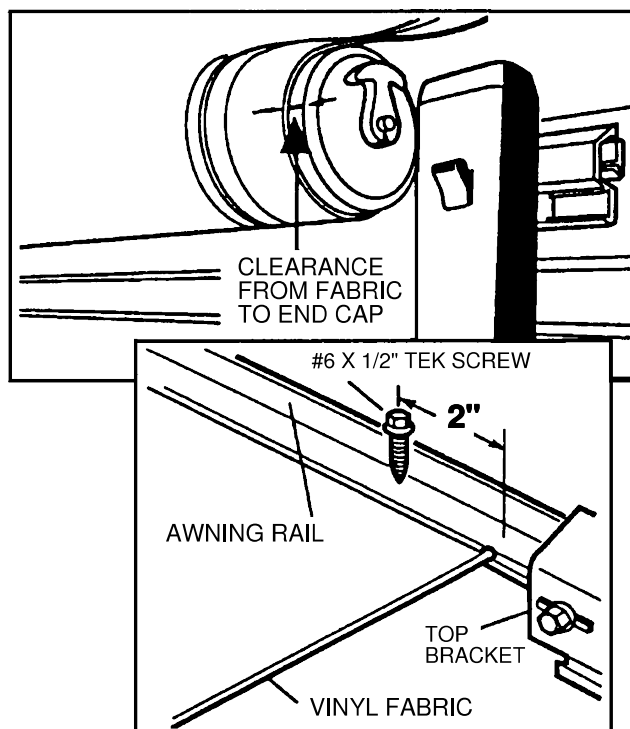
2.1 POSITION

Open the awning and check the position of the fabric between the top mounting brackets. If the fabric is not centered, remove the tek screws, center it, and replace the screws.

When the fabric is properly positioned, next check the position of the fabric on the roller tube. The clearance from the end cap of the torsion assembly to the edge of the fabric must be the same on each end. If it is not, adjust the fabric on the tube as necessary. On the Elite 9000 and 9500 awning the fabric is held in place to the weatherguard with 1/8" pop rivets. Check the position of the fabric at each end of the weatherguard. If the fabric has shifted, remove the pop rivets, center the fabric and re-rivet.

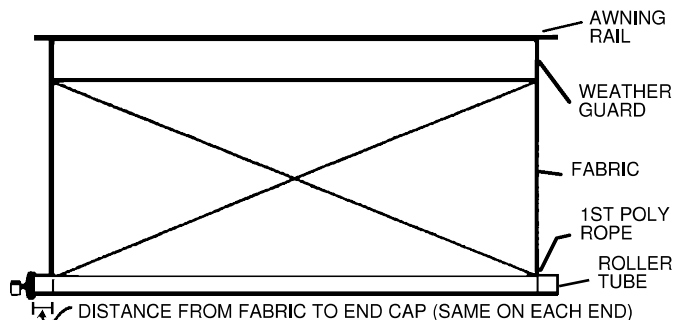
2.2 SQUARE

To check fabric for square, measure from the top right hand corner of the fabric (not the weatherguard) to the bottom left hand corner at the poly rope. Now measure from the top left hand corner to the bottom right hand corner as shown below.

In this check, the difference of the two dimensions should be no more than one inch. If it is more, the fabric is out of square, and replacement would be necessary.

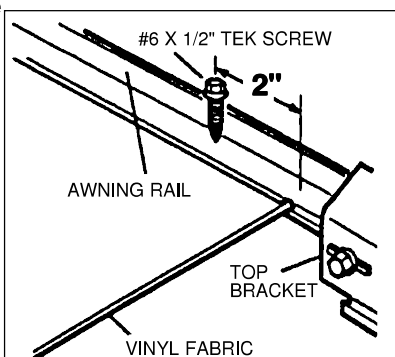
2.3 WEATHERGUARD

The weatherguard is the last 15 inches of the awning that encloses the fabric in the rolled up position. It protects the striped fabric from the environment and elements. The weatherguard is a heavy 17 oz. vinyl fabric.

When the vinyl weatherguard or fabric has excessive wrinkles, it will be necessary to stretch the weatherguard or fabric. Open the awning and allow the fabric to warm up. Remove one Tek screw, grasp the weatherguard, stretch it, and resecure the screw. Repeat this procedure for the other end, making sure to stretch each side an equal distance, keeping the fabric centered between the top mounting brackets. Close and reopen the awning three times. If wrinkles are still present, repeat the above stretching procedure. This may have to be done 4 or 5 times before all wrinkles disappear.

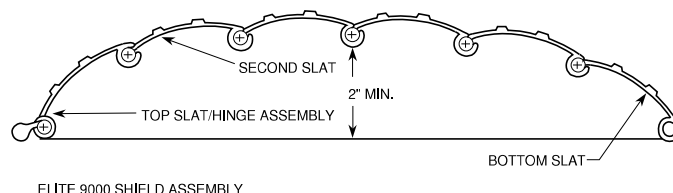
When the awning is fully extended, the aluminum guard should have an arch of at least 2 inches. The arch helps water to run off rather than between the sections of the guard.

To check the aluminum guard for proper arch, open the awning to full extension, making sure the fabric is taut. Hold a flat edge to the bottom of the guard and measure from the flat edge to the inside of the arch at its highest point. If the measurement is less than 2 inches, the guard should be replaced.

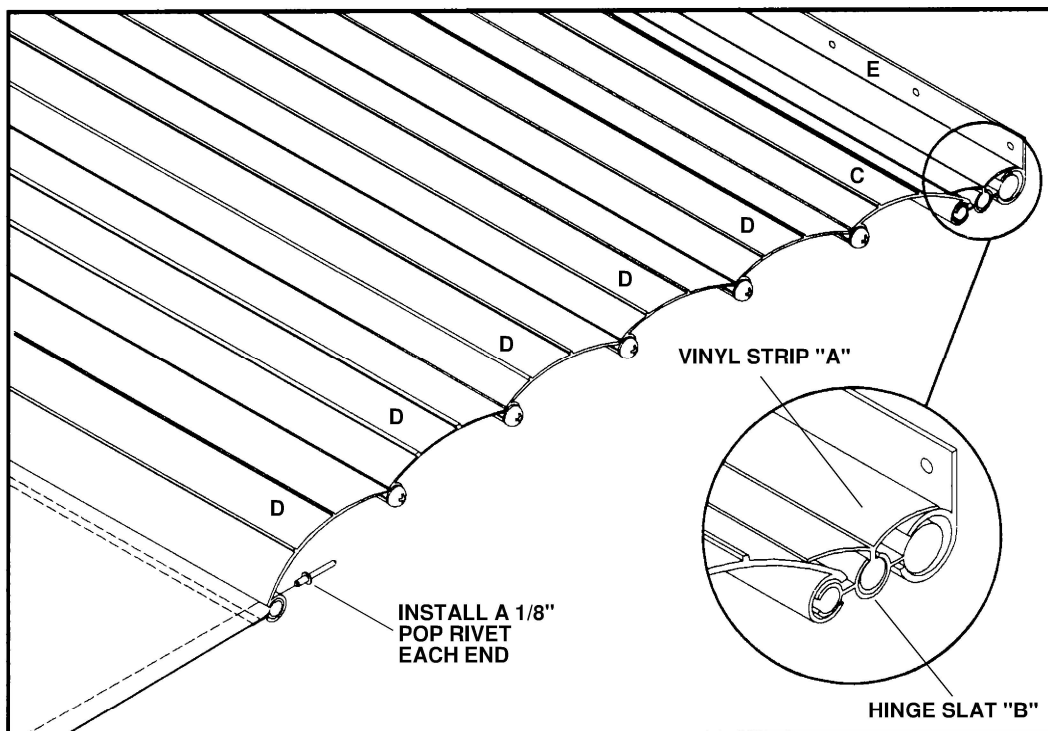
9000 WITH HINGE SLAT

A - VINYL STRIP
B - HINGE SLAT
C - TOP SLAT
D - MAIN SLAT
E - AWNING RAIL

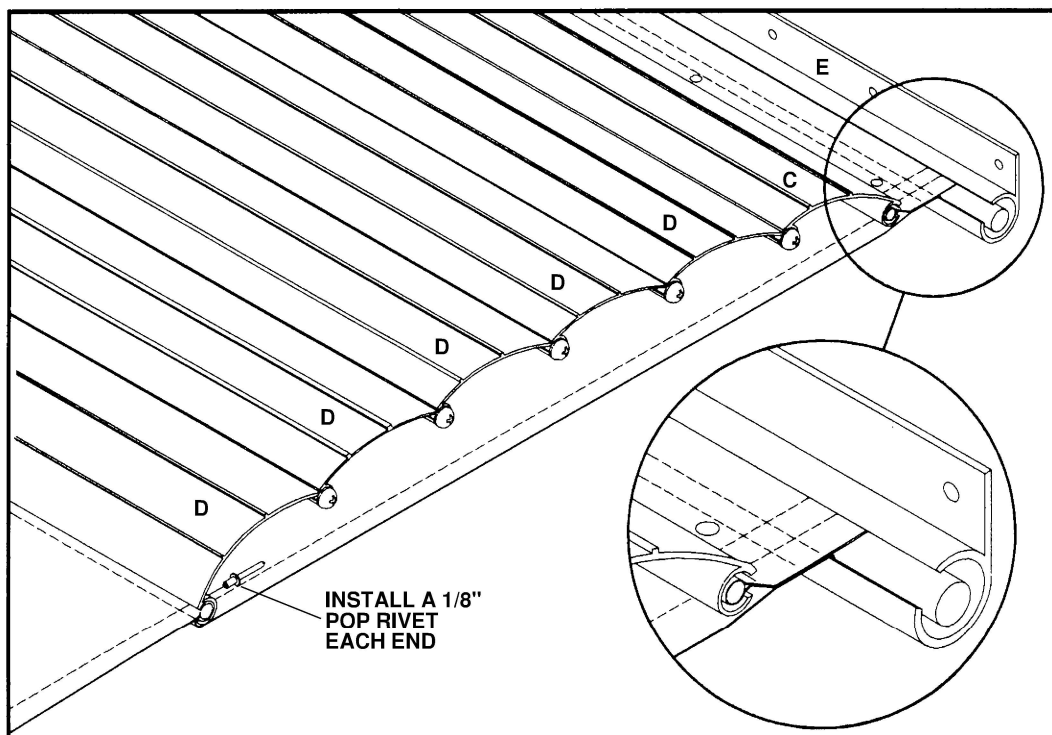
TOP SLAT "C"
VIEW RH END

MAIN SLAT "D"
VIEW RH END

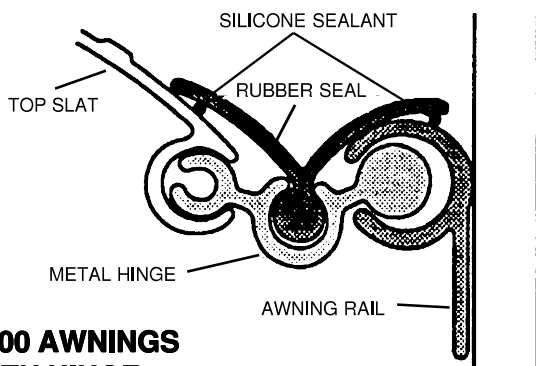
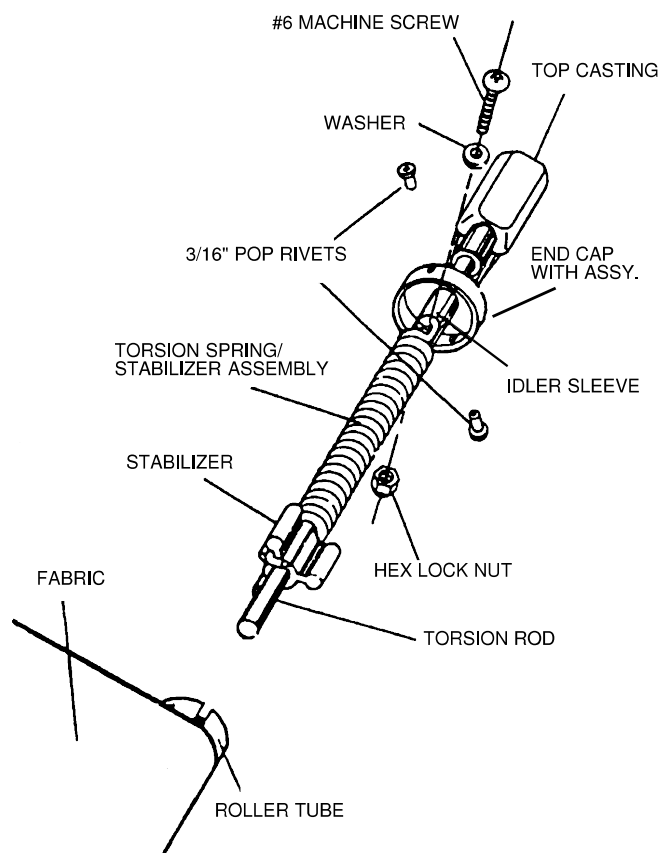
**9000 AWNINGS
WITH HINGE
SLAT**

The torsion assembly has a wound coil spring which

provides tension on the roller tube to roll the awning up into the travel position.

The right hand torsion end cap contains a cam assembly which prevents the awning from billowing or unrolling during travel. It also allows one-person set-up of the awning by preventing rollback.

When difficulties are experienced in rolling the awning up, the tension on the torsion should be checked. In

most cases adding a few turns of torque to each end will correct the problem. If all tension has been lost, refer to the following chart and apply the specified number of turns as indicated. This must be done with the awning extended two feet away from the coach.

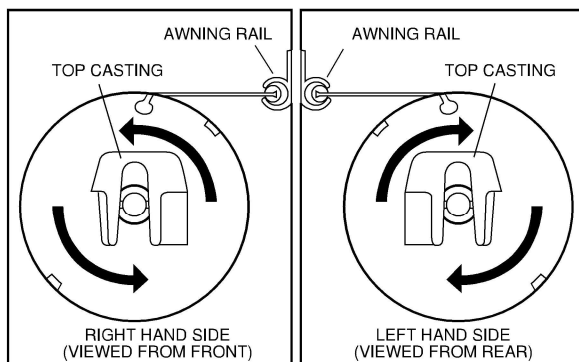
See Spring Identification Chart for No. of Turns

When winding the torsion, be sure to wind in the proper direction.

SEVERE INJURIES CAN RESULT FROM THE SPINNING TOP CASTING. USE VISE GRIPS® (NEVER BARE HANDS) TO GRASP TOP CASTING WHILE LOADING TORSION.

Note: Rewinding must be done with the Awning Fabric extended two feet away from the coach.

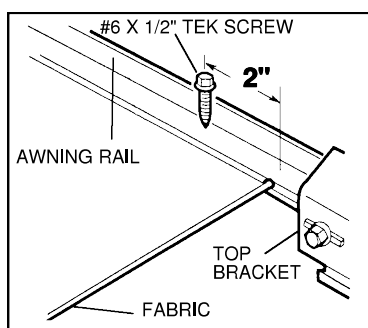
2.12 TEK SCREWS

The Tek screws are the two screws installed through the awning rail of the coach. They keep the aluminum guard from shifting in the awning rail. On vinyl and some acrylic awnings (see Sec. 2.5) they keep the fabric from shrinking with age. If one Tek screw is missing, the fabric will pull toward the remaining Tek screw causing the fabric to wrinkle.

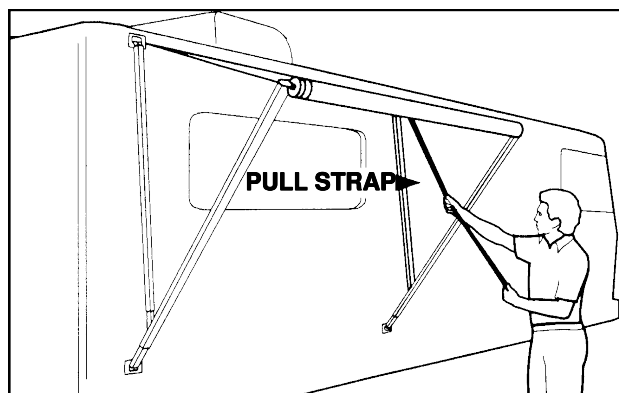
3.2 CLOSING

On the 9000 and 9500 Series, when rolling up the awning, the roller tube assembly should not be slowed down before reaching the aluminum guard. This could cause the roller tube to stall at the guard.

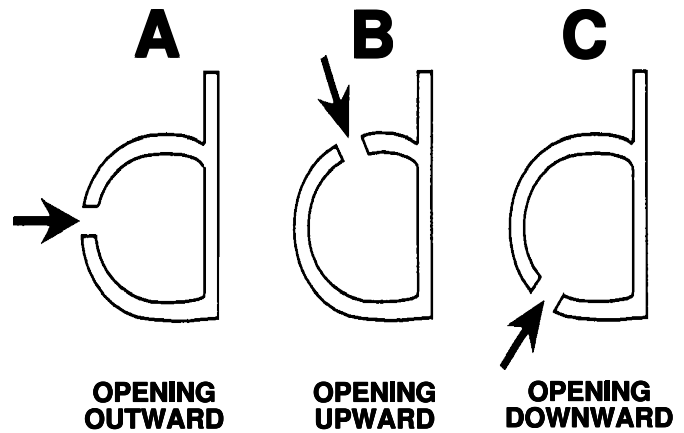
4.3 TYPE

There are three types of awning rail used in the RV industry. Of these, type A and B (see below) are acceptable for use on the 9000 Series awning that utilizes a hinge slat (see Sec.2.5) . Type C should never be used on the 9000 Series that utilizes a hinge slat (see Sec. 2.5) as it could cause a binding problem on the aluminum guard assembly, but it is acceptable on the vinyl awnings.
