Service Bulletin: RM1350 Poor performance issues check the following, prior to replacing the cooling unit.

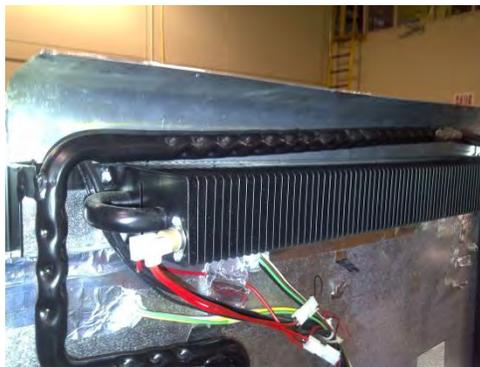
- The first automatic frost reduction begins 60 hours after turning on the refrigerator. To set this, the 12vdc should be disconnected for 2 minutes. This should be done between 12pm to 3pm. This will ensure that the defrost cycle happens during the night time hours and not during the day. After the first defrost cycle, it will repeat every 48hours.
- Place an air foil at the top of the condenser fins with a radius to direct the air across the coils. [Kit # 3314371.000](#)

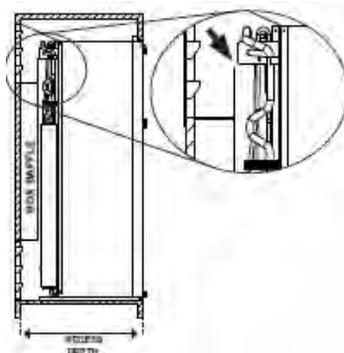
- Maximum of 1" distance from the back of the coils to the back wall of the slide room.
- If there is more than 1" distance, create a full box baffle that goes from the top of the bottom sidewall vent to within a ¼" of the bottom of the condenser fins.

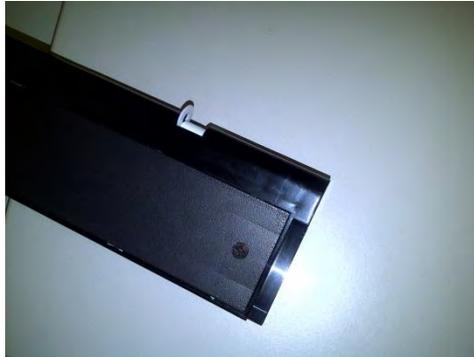
- Inspect the fresh food door flapper and make sure that it is closing fully. Perform the dollar bill test. Make sure that the door gasket is fully seated around all door(s). If not, press the gasket firmly in the channel. If the gasket is cracked replace with a replacement gasket. If the gasket is good but air gaps at the flapper then replace the flapper. The flapper kit includes two shims, which may be needed to adjust the flapper, to ensure that it does not bind up and operates smoothly. Install the shims below the top hinge as shown in the picture. [Kit # 3313470.025](#).

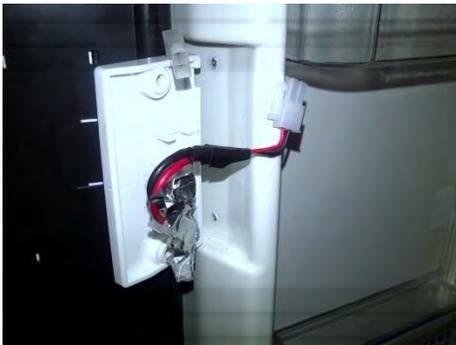
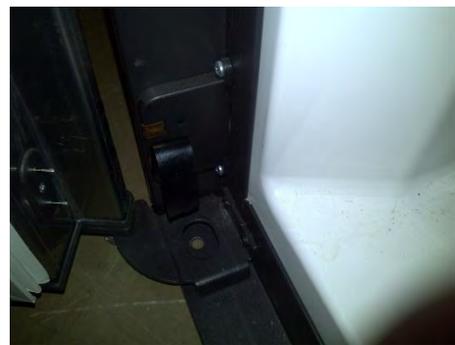
- For low humidity conditions, the flapper can be disconnected. This is done by removing the screws and disconnecting the moxex plug. The fridge should be monitored for any condensation on the flapper. As a test, the contact points can be covered with tape, instead of disconnecting the plug. See photos below:

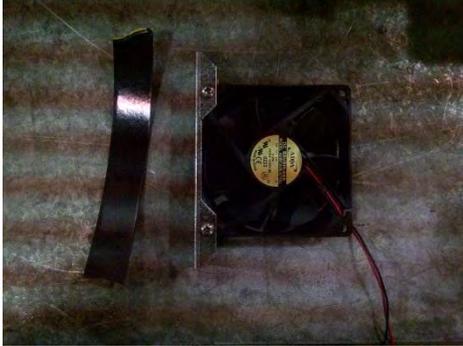
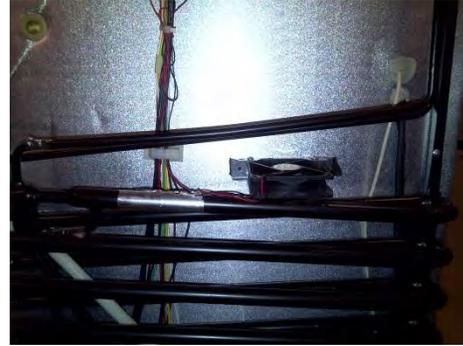
- Install a third fan directly above the absorber 7" in from the right side of the refrigerator. [Kit # 3313470.026](#).
- Clean the fan bracket and the back of the fridge using an alcohol swab. Attach the fan to the back of the fridge and use butt type connectors to attach to the other fan harness.
